17th St Canal Floodwall, Orleans Parish, Vets to Lake Field Trip 8 Nov 94 Photo Captions

MEMORANDUM FOR FILE

SUBJECT: 17th Street Canal Floodwall, Orleans Parish,

Vets to Lake, Field Trip Report

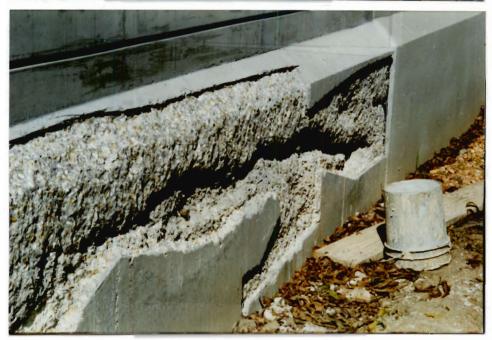
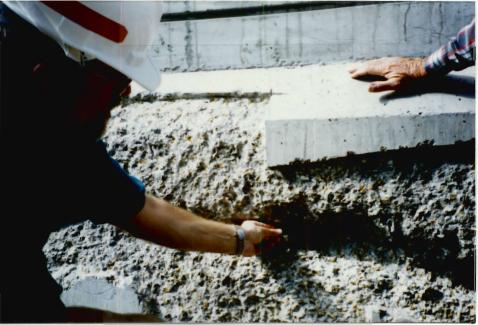
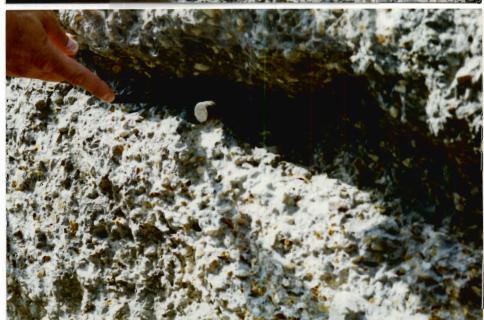
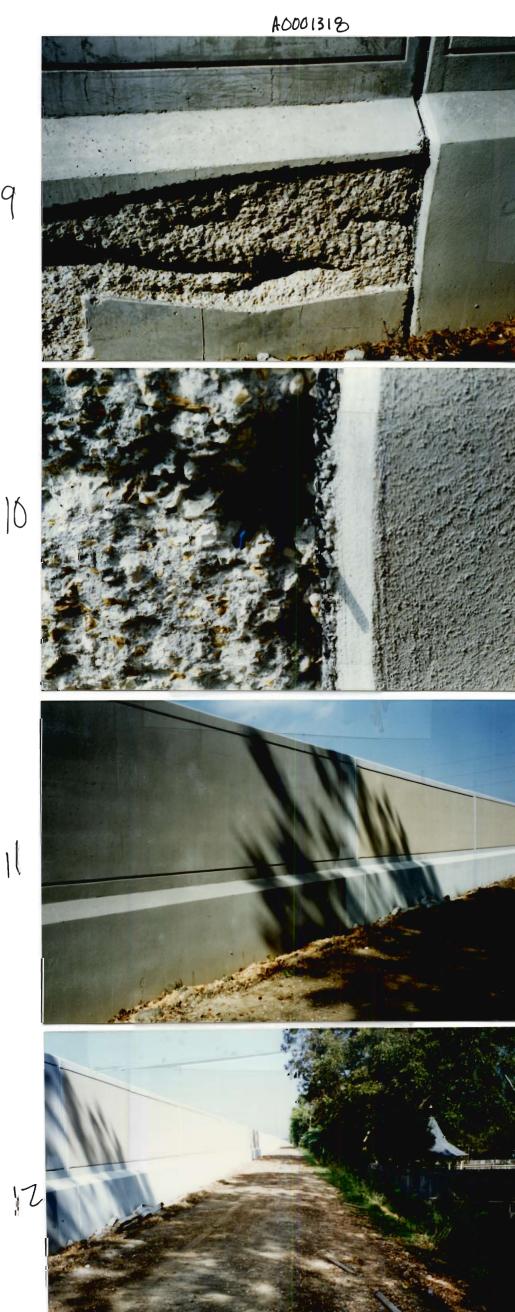
Photo No.	Remarks
1	General view of defective wall and access road looking towards Vets Hwy.
2 - 4	Area where honeycombed concrete was removed by Contractor.
5 - 6	Note layering of concrete on bottom left of defective area. Note feathered edges along bottom center of defective area.
6 - 8	Deep area of honeycombing near steel bar.
9 - 10	Deep area near expansion joint
11	View of adjacent monolith looking towards lake.
12	General view of wall and access road looking towards lake.

- 6. Observations: See photos with captions.
- 7. <u>Conclusions</u>: The monolith can be repaired by patching to achieve its desired function. Some additional concrete needs to be removed near the bottom center as shown in photo 5. Additionally, a few more edges need to be sawcut rather than left feathered.

- 8. Recommendations: Remove the additional concrete as shown in photo 5 and sawcut the edges that are still feathered. Saturate the surface for about 12 hours prior to patching. Allow the surface to begin the drying process the night before patching. Apply a neat cement mortar as a bonding agent, then dry pack a material as described in the specs. White cement is not necessary since the wall will be coated with cementitious paint. Protect and cure the patched area as specified.
